AX5 And AX15 5-Speed

By Mike Weinberg
Contributing Editor

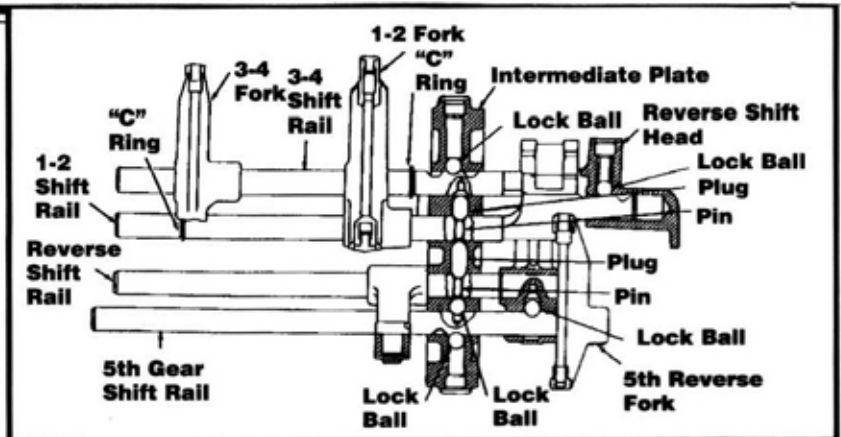
2. After rebuild the trans functions properly but gets stuck in reverse, 5th or two gears at once.

Solution – Missing or incorrectly located detent balls or interlock pins. Refer to Figure 4 for proper placement of detents and interlocks. Be extremely careful on tear-down to note the locations and prevent the loss of the pins and balls.
