Solving Difficult Problems: Think Outside the Box

**By Mike Weinberg
Contributing Editor**

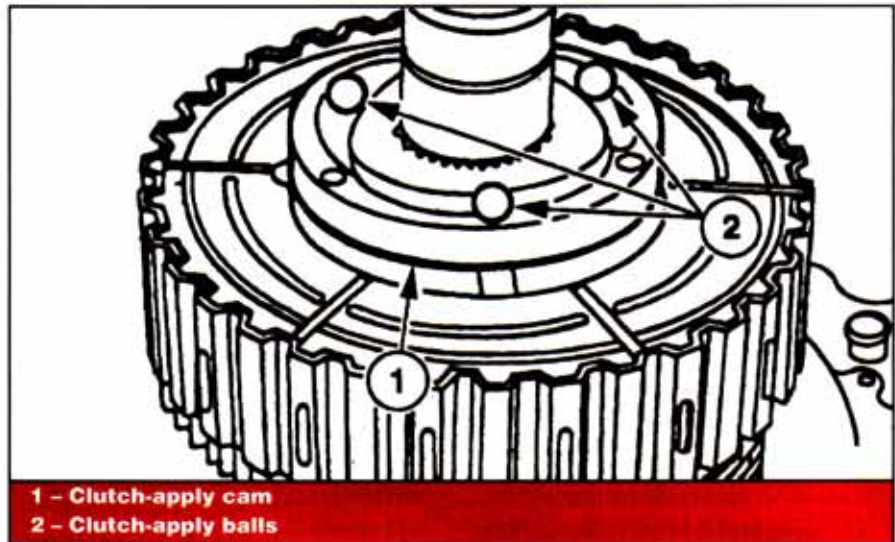
the balls and cam that apply the clutch pack (see illustration) were wedged in the full apply position and could not be released without disassembly. This is a common situation in the 4405 and 4406 transfer cases when they are driven in the full four-wheel-drive position on dry pavement for an extended period.

The shop then sent the vehicle to a local Ford dealer for diagnosis. The Ford dealer was able to locate a broken ground wire in the transfer-case harness, and when that was repaired the vehicle operated correctly. The loss of ground on the circuit (unknown at this point) caused the computer to signal full clutch apply, creating a full-time 100% duty cycle on the clutch pack, and the continuous operation on dry pavement wedged the balls and the apply cam into terminal lockup.
