Repair procedures

New Venture 261 & 263 transfer cases

Repairing the New Venture 261 & 263 Transfer Cases

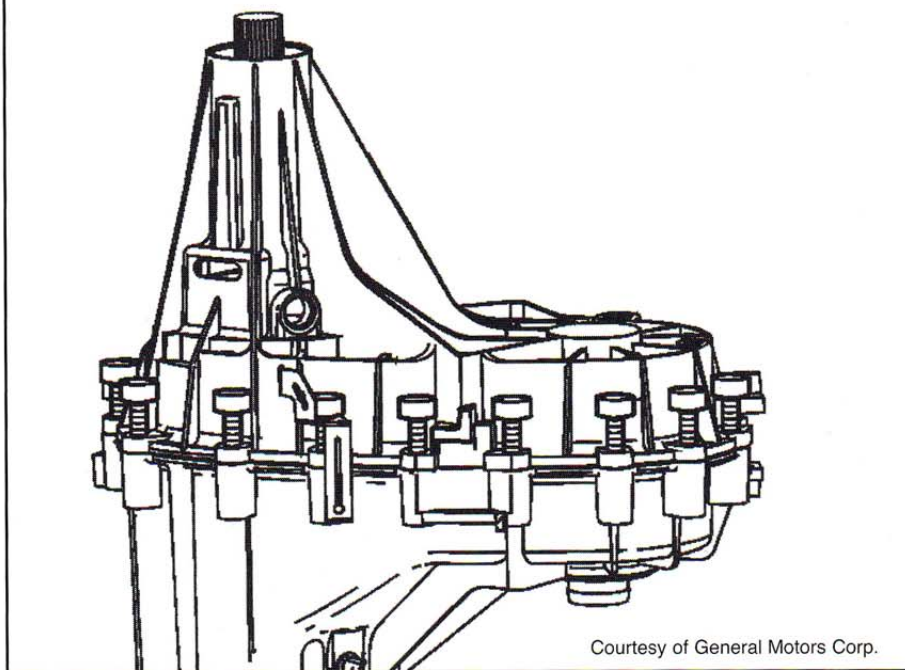
Figure 2

View of case-half bolts or studs and aluminum washers

Another problem with magnesium is “galvanic corrosion,” which is the scientific name for the migration of atoms between two dissimilar metals (steel and magnesium). The bolts that fasten the case halves together are steel and come from the factory with cup-shaped aluminum washers to keep the bolt heads off the case (see Figure 2). If you lose a bolt do not replace it with a plain steel bolt or there will be extreme corrosion of the cases. The fill and drain plugs on these transfer cases are made of aluminum and should not be replaced with steel or brass plugs for the same reason. All the external seals for these units should have rubber coating on the outer flanges that butt up to the cases.

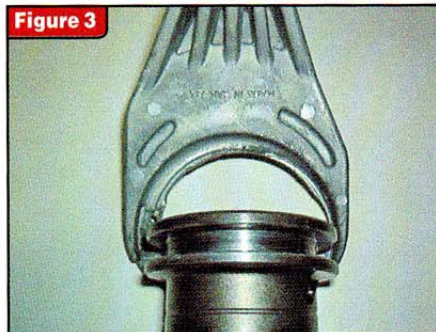
Figure 3

These units suffer from lube-related internal problems. The specified fill from the factory is ATF. These units run hot, particularly behind the Allison units. We are not sure at this point whether the magnesium transfers heat better than aluminum and acts as a “heat sink,” but these transfer cases run hot enough to cause the ATF to vaporize and leave the transfer case

through the vent, causing various lube-related failures to the low-range fork and range sleeve, and the drive sprocket to the main shaft (see figures 3 through 8).

Damage to the low-range fork and hub

These units are equipped with a gerotor-type oil pump driven off the mainshaft to provide pressurized lube to the internal components. Substitute 5W30 motor oil for the ATF when filling the trans-

fer case and add an extra quart of oil through the speed-sensor opening at the rear of the case. It would be smart to advise the customer to have the transfer-case oil checked every 5,000 miles and changed every 10,000 miles. Every one of these units that we see has either low or no lube and the oil is burned black. We are researching the oil problem further, and when we come up with a more-refined solution we will bring it to you in a future edition of the magazine.

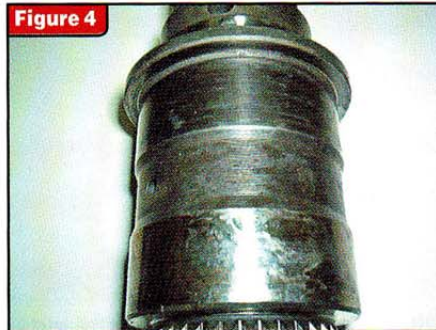
Figure 4

Brinelling of mainshaft sprocket journal

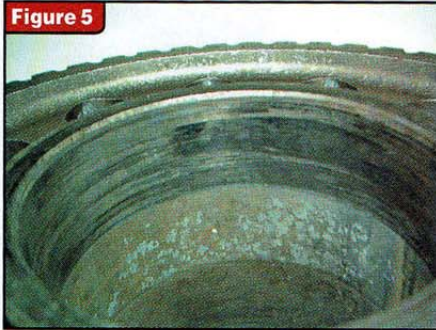
Figure 5
Internal sprocket damage

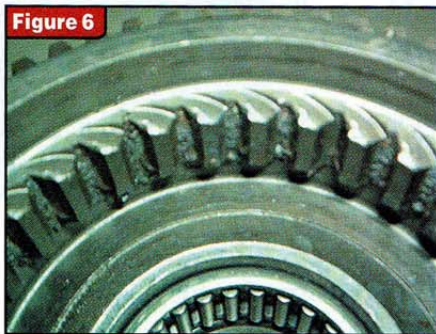
Figure 6
Internal contamination of input shaft

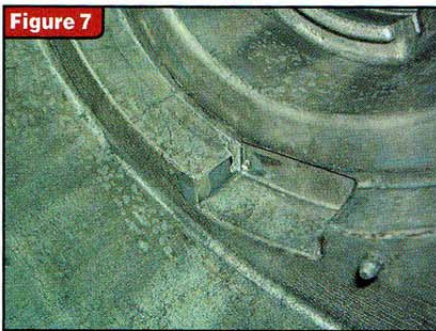
Figure 7
Hole in case caused by pump wear

The second common problem is wear to the case caused by the movement of the oil-pump housing. Included in the design is a small steel wear plate on a cast-in peg in the rear case half (see Figure 9). The wear plate usually migrates from its intended position during use, and the oil pump beats a notch into the case. When you are rebuilding one of these units, coat the back of the wear plate with RTV silicone to ensure that it does not move. If you have a unit with this type of case wear, you will need to replace the case half and the oil pump. When the oil pump can travel because of the wear in

the case, the oil-pump housing will damage itself on the other lugs that locate it in the case and will need replacement. Carefully inspect the oil pickup filter, pickup tube and O-ring to make sure they are not blocked with debris or leaking.

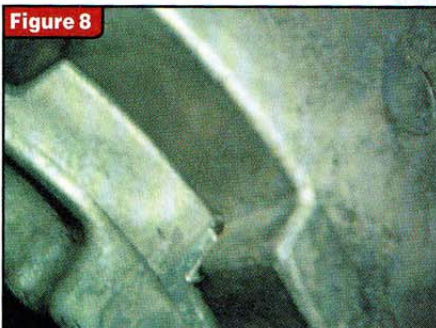
Figure 8
Oil-pump wear on the opposite side of the case caused by wear on the pump housing

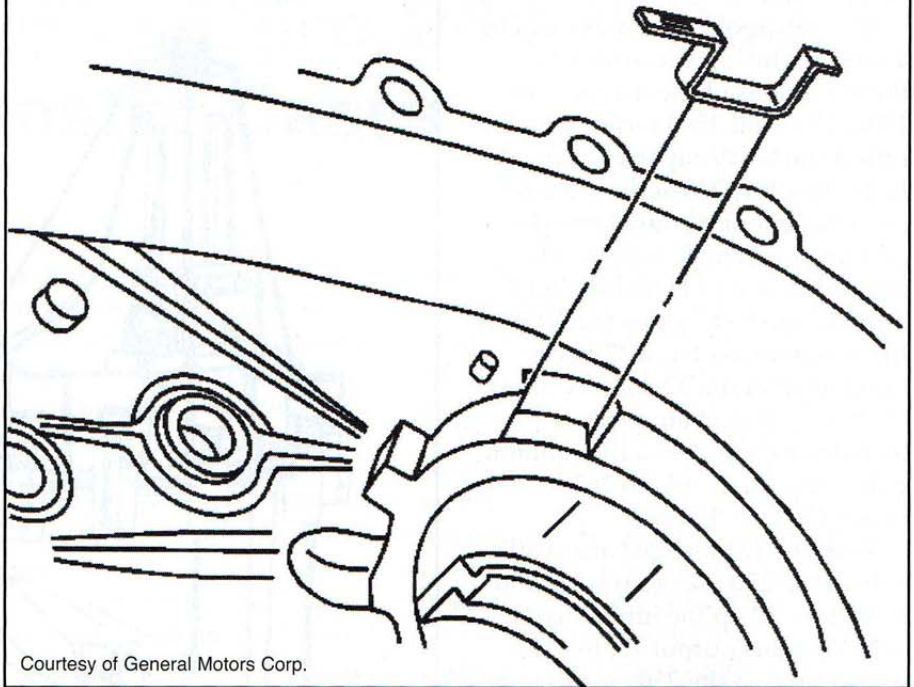
Figure 9

Oil-pump wear sleeve
